Inspection Report

Minerals Regulatory Program

Mine Name: Aragonite
Operator Name: Star Stone Quarries

Permit number: M0450031
Inspection Date: April 20, 2006
Time: 11:00 AM to 12:00 PM

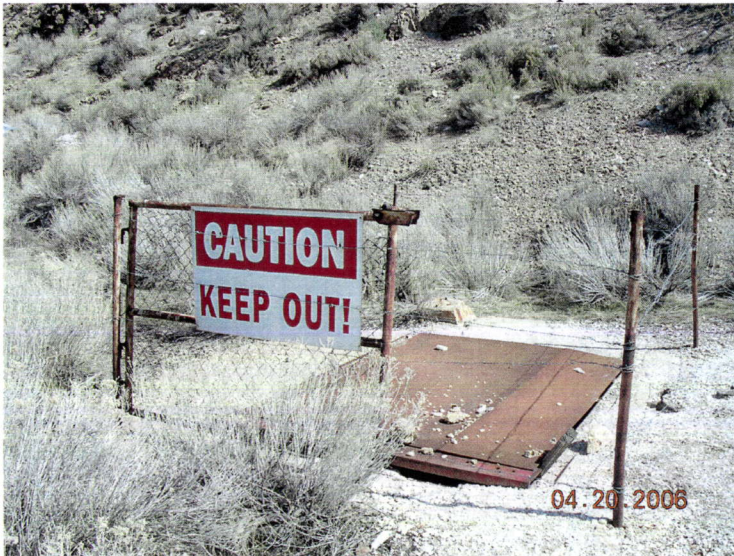
2. Public Safety (shafts, adits, trash, signs, highwalls)
There is a barbed wire fence around the shaft, and there is a sign saying, "Caution! Keep Out" (Photo 1). There is also a steel plate over the top of the shaft that appears to be welded on. I was not able to open it. Although the fence is intact, it is a high gauge wire and is loose.

Photo 1. The shaft. The barbed wire is a thin gauge.

The fences need to be tightened and repaired.

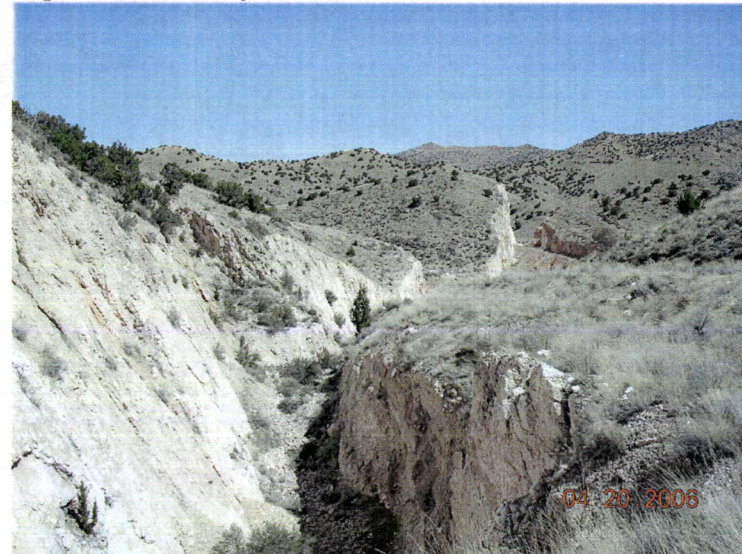
This site has two large cuts (Photos 2 and 3). According to a map in the plan, the southern cut is old and is not part of the permitted area. This cut contains some old workings (Photo 8).

Photo 3. The south cut.

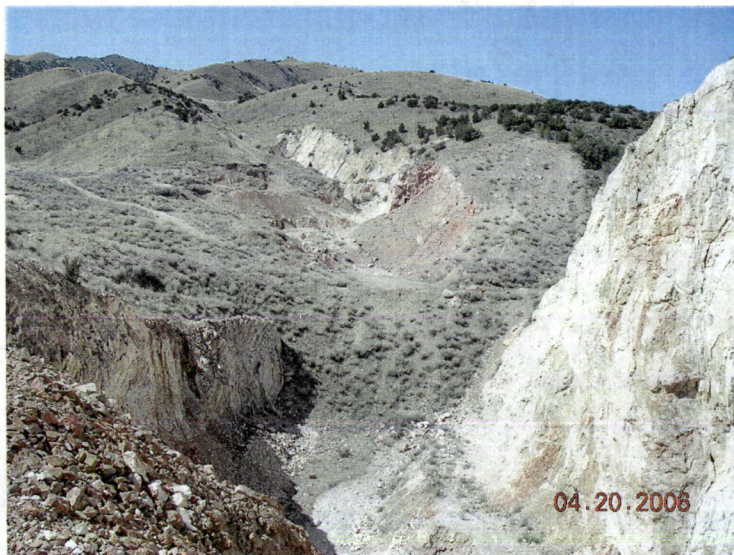
Photo 2. The north cut is in the foreground with the south cut in the background.

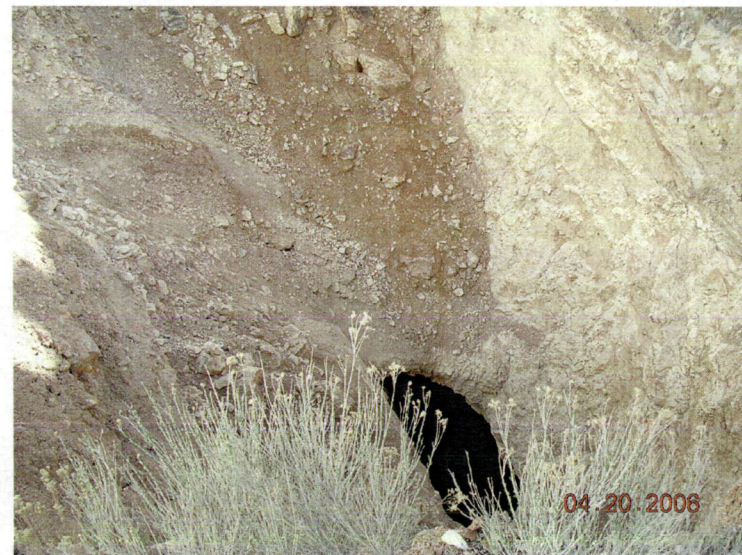
The cut on the north is part of the permitted area, and it contains two shafts (Photos 4 through 7). There are fences across the northern and southern ends of the cut to restrict access to the shaft areas. Although these fences are intact and are fairly secure, it would be easy to cross them.

Photo 4. This is the southernmost of the shafts in the north cut.

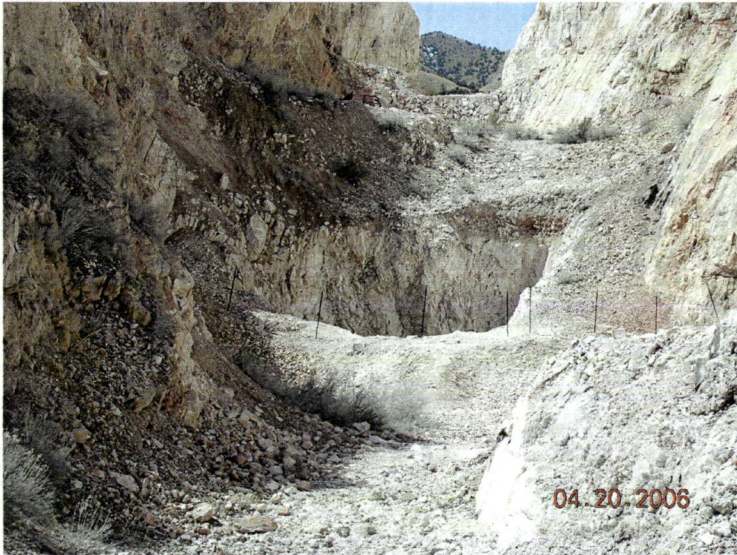
Photo 5. This shows the fence on the north side of the north cut, and the holes in Photos 6 and 7 are in this shaft.

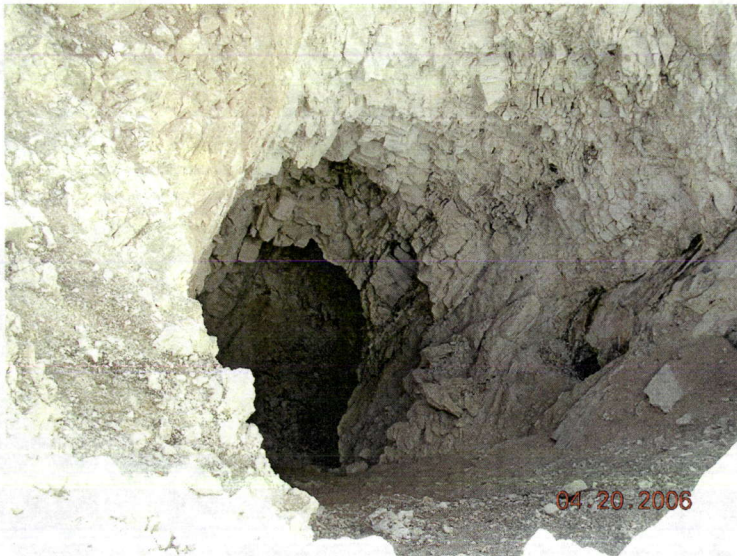
Photo 6. This hole and the one in Photo 7 are toward the north side of the north cut.

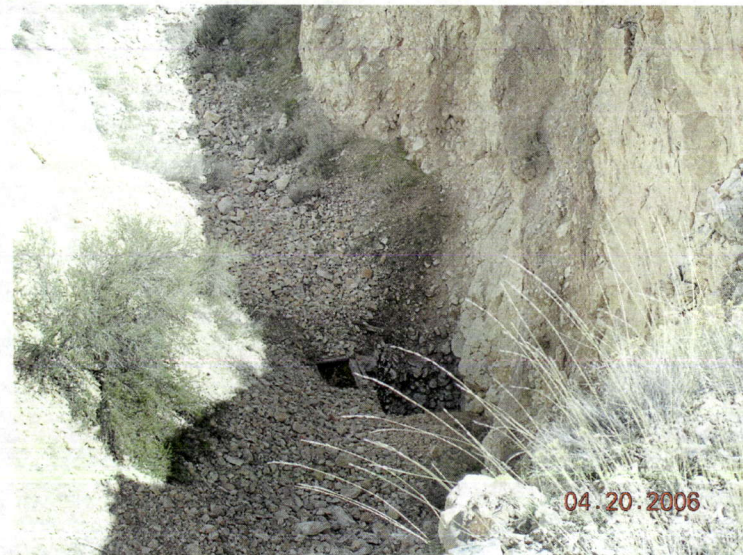
Photo 8. This shows what appears to be old workings in the south cut.
